4. CONTAMINATION SITE CPP-82

4.1 Summary

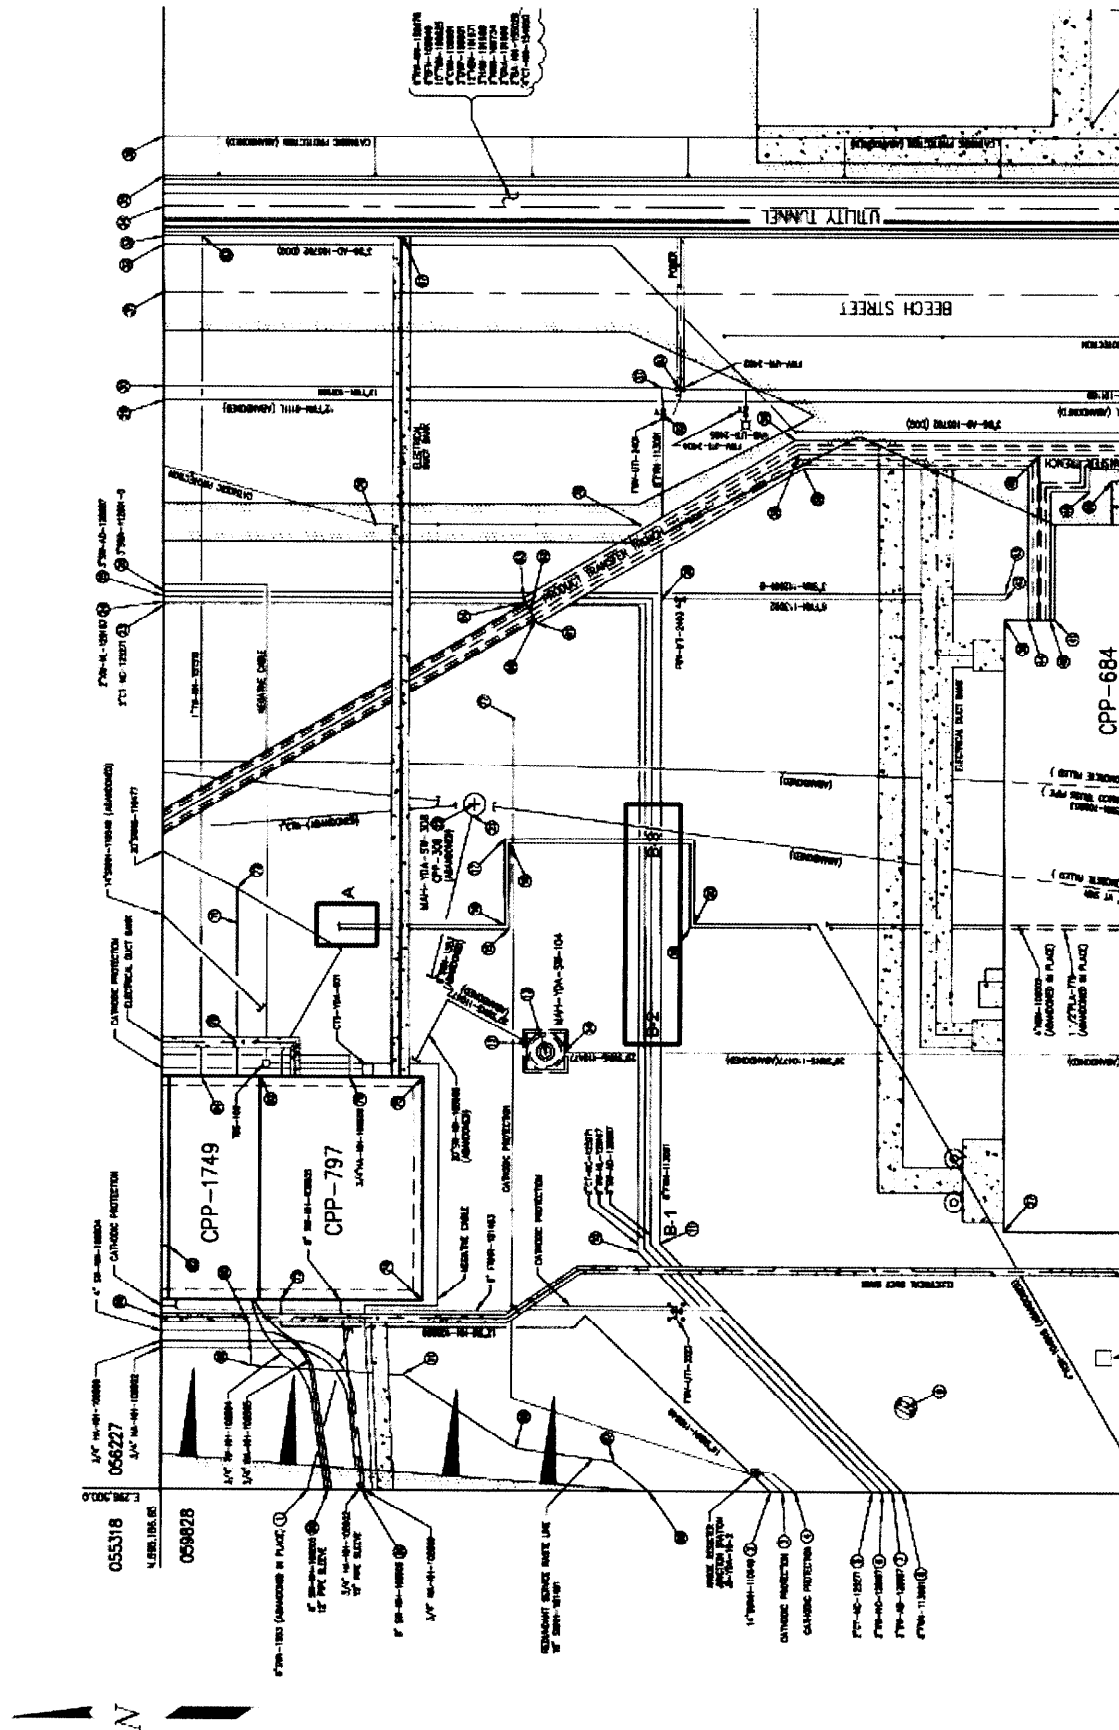
Figure 4-1. Schematic showing Locations A, B-1, B-2, and B-3 of Site CPP-82.

Site CPP-82 (abandoned 1.5-in. line, PLA-776, west of Beech Street) is the location of three excavation-related buried pipeline incidents that occurred in August and September 1987 (designated Locations A, B, and C) during excavation for the construction of Building CPP-797, which would replace service waste buildings CPP-734 and CPP-709 (see Figures 2-1, 4-1, and 4-2). Location A involved the rupture of an abandoned line and the release of 2.5 gal of low-level radioactive liquid waste. Locations B and C are associated with the release of nonradioactive, nonhazardous waste water; these spills occurred during the repair activities associated with Location A. The Track 1 decision documentation (WINCO 1992b), approved in 1993, determined that “No Further Action” was justified. At the time of issuing the OU 3-13 ROD, Site CPP-82 was transferred to OU 3-14 for further evaluation (DOE-ID 1999).

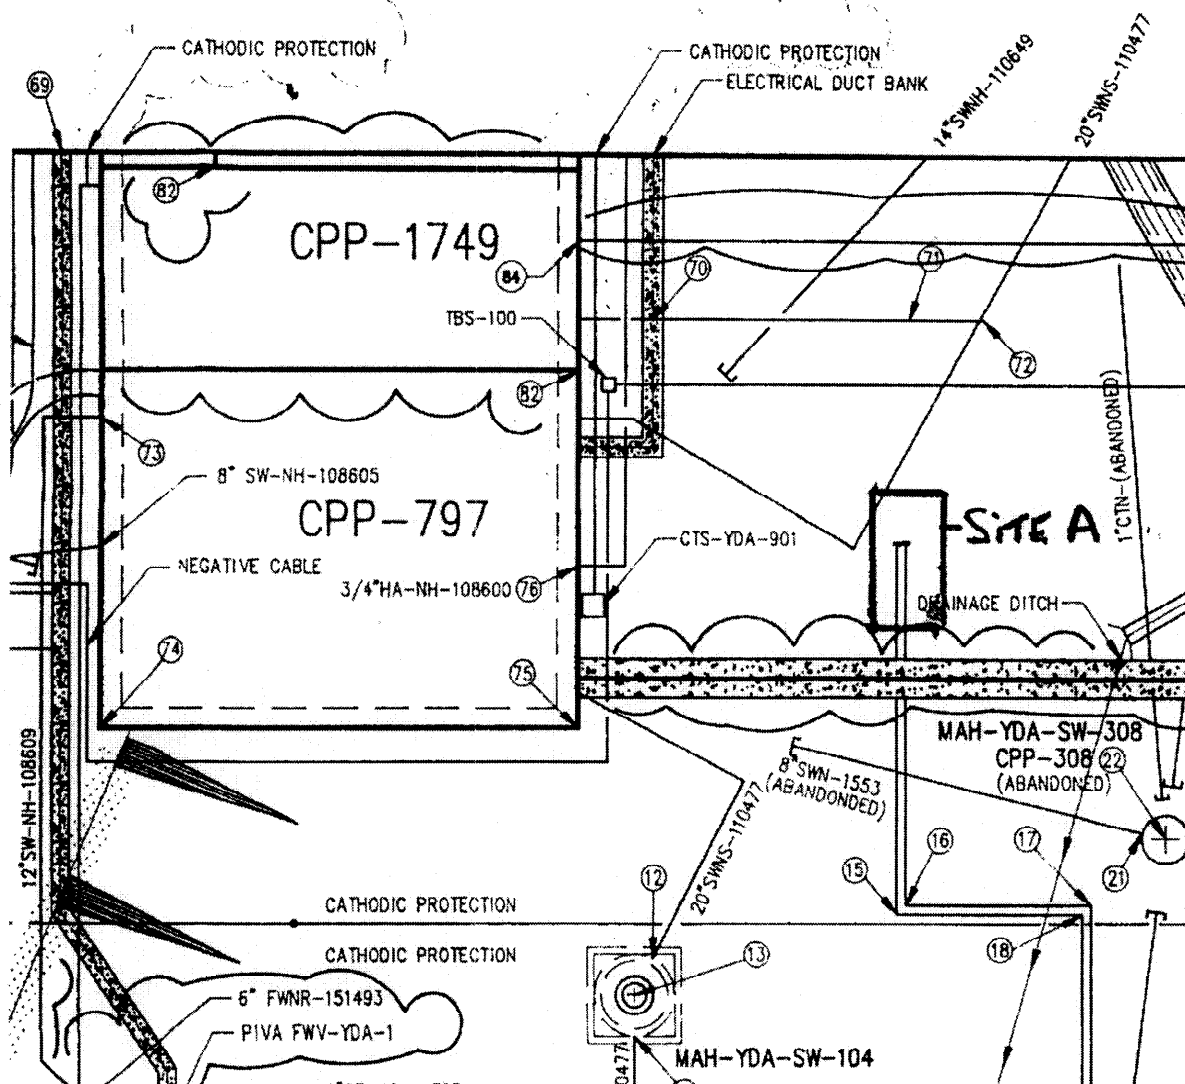
Figure 4-3. Schematic from Track 1 (WINCO 1992b) showing Location (Site) A.

During excavation for the construction of Building CPP-797 in August of 1987, a backhoe struck and ruptured an abandoned underground line, PLA-776 (1.5-in. stainless steel pipe). This locale, known as Location A, is located approximately 20 ft east of CPP-797 where the line runs north to south (see Figures 2-1 and 4-3). The line PLA-776 previously carried low-level radioactive waste from the CPP-603 (Fuel Storage) waste tank, SFE-126, to the process equipment waste (PEW) evaporator feed tank, WL-133. The source of the radioactive contamination was the cleanup system for the CPP-603 basin water. Fission products (Cs, Sr, I) and small amounts of U and Pu (accounts for the observed alpha contamination) were released into the basin water from damaged fuel elements and were gathered up by the water treatment system. The rupture resulted in the release of about 2.5 gal (9.4 L) of low-level radioactive liquid waste. The release was contained within the excavation hole by an immediate temporary corrective action to prevent the liquid from draining out (the line was bent up and sealed with tape) and the line was monitored for radioactivity (about 7 cpm alpha and 20,000 cpm beta-gamma). All contaminated soil above background (during the time of the release, 1987, typical background levels at cold INTEC areas were 300 cpm beta-gamma^a) was collected and packaged for disposal as radioactive waste at the Radioactive Waste Management Complex (RWMC). Standard practices mandated that health physics surveys be conducted throughout the removal action to identify all contaminated soil (WINCO 1992b).

spilled liquid was small (2.5 gal) and localized, it was easily identifiable for removal (memo in Reference 7, WINCO [1992b]). Following the corrective action, the site was surveyed to ensure that all contaminated soil above background was identified for removal from the excavation area (Reference 6, WINCO [1992b]).

Further correction included excavating the pipe 10 ft beyond the designated excavation limit and permanently capping the abandoned pipe in-place with compatible materials based on standard practices. The broken line, excavated line, and soil with activity above background were bagged for disposal as radioactive waste at the RWMC (Critique Report No. 87129, Reference 1, WINCO [1992b]). Where the

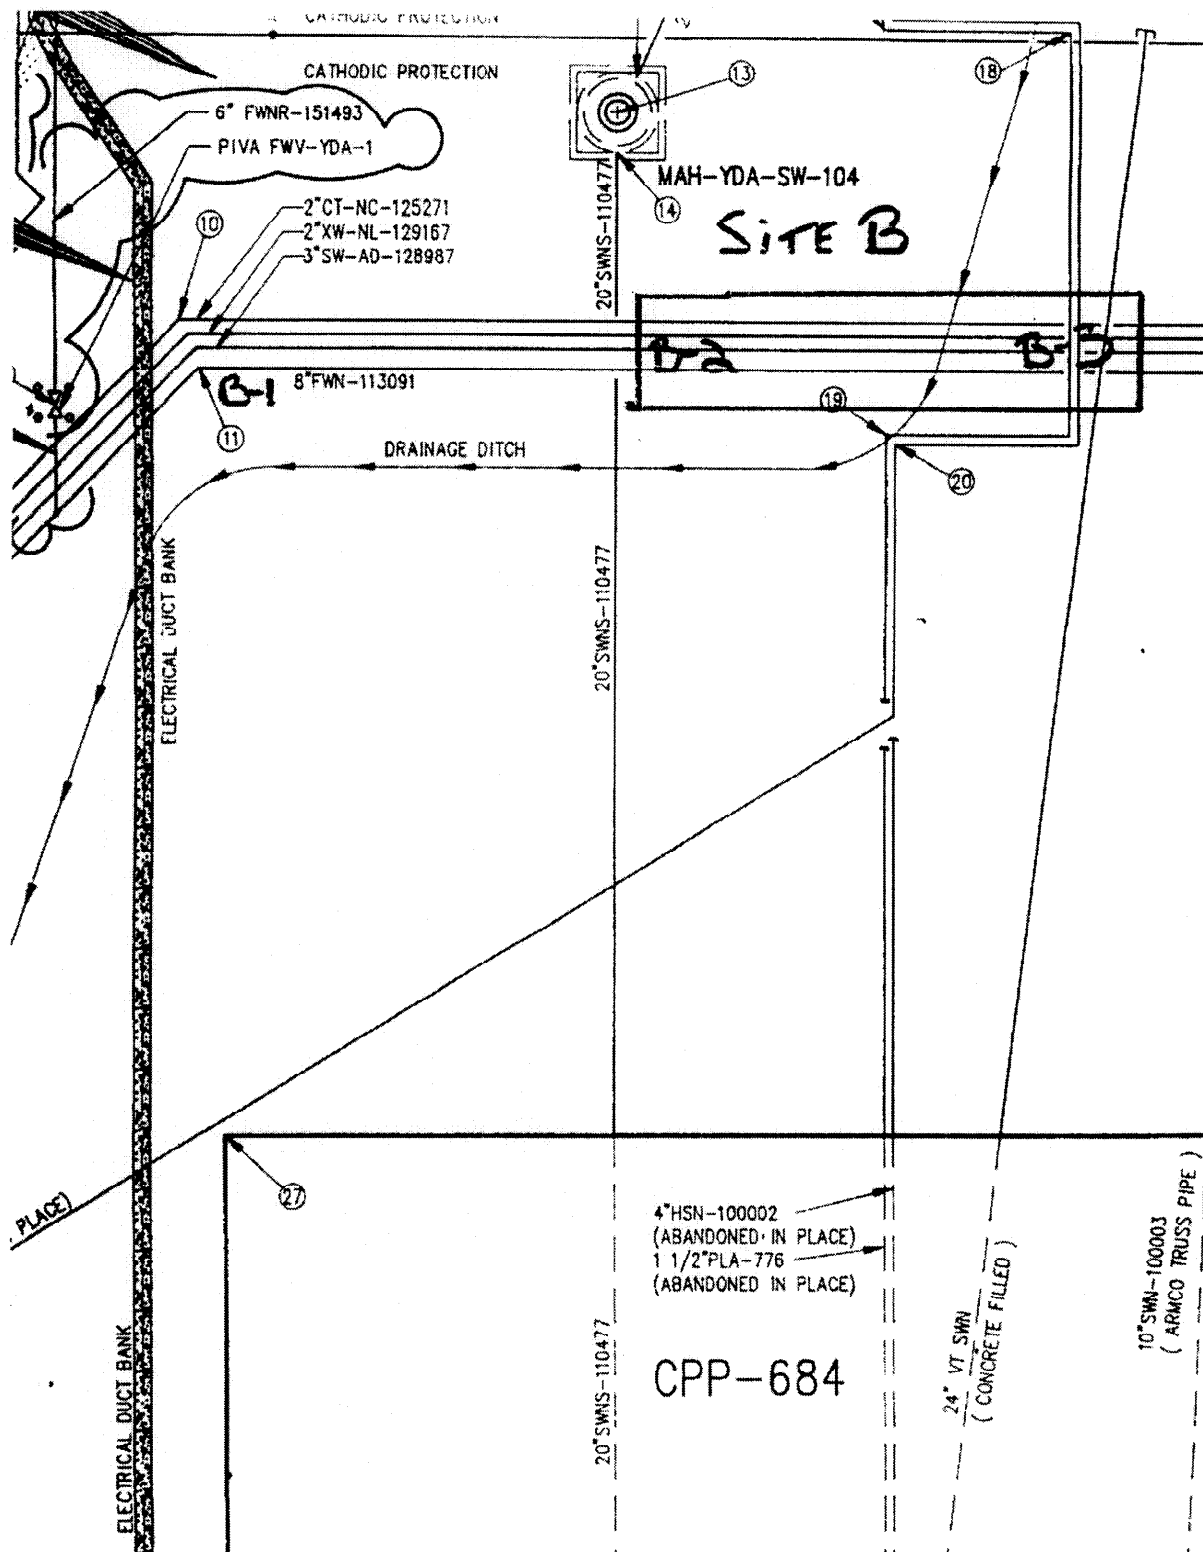
Figure 4-4. Schematic from WINCO (1992b) showing Location (Site) B.

On September 2, 1987, during the corrective action activities associated with Location A, a similar situation occurred at three locations called B-1, B-2, and B-3. Based on personnel interviews, approximately 25 gal of service wastewater may have been released at location B-2 (Reference 6, WINCO [1992b]). There were no releases at B-1 or B-3. The situation involved four parallel underground lines (CT-NC-125271, XW-NC-129167, SW-AD-128987, and FWN-113091) that are located south of CPP-797 and run east to west. These lines carried service wastewater from the Fluorinel Dissolution Process and Fuel Storage (FAST) Facility in Building CPP-666 to valve box DVB-YDA-SW-D12 along Beech Avenue and then to service waste building CPP-734 (replaced by CPP-797). Here, the solution in the lines was monitored, combined, and released to the service waste system. In this incident, three of the lines were damaged at separate locations, designated as B-1, B-2, and B-3, when they were struck by equipment (Figures 4-1 and 4-4). The fourth line, 8 in.-FWN-113091, was not damaged; it contained fire water (raw water). The three damaged lines are discussed below:

- **Location B-1:** There was no release at this location, which involved the 3-in. service waste line, SW-AD-128987. This line was contacted and deformed but not ruptured in the incident. Therefore, no liquid or contamination was released in the incident. The deformed section was later replaced. Location is approximately 30 ft south of CPP-797.

- **Location B-2:** At this location, approximately 30 ft south of the southeast corner of CPP-797, two lines were intercepted and at least one of the lines led to a release. The 2-in. plastic line XW-NL-129167 was torn and made useless; a small quantity, about 25 gal of water (nonhazardous, nonradioactive) was released. Immediate corrective action involved tagging the line out of service. The damaged section was replaced.

- **Location B-3:** At this location, the 2-in. line CT-NC-125271 was deformed but not ruptured. Therefore, no liquid was released. The deformed section was later replaced. The previous bullet discusses the steam condensate contained in this line.

In repairing the lines discussed above, the lines were hydrotested to ensure their integrity after being replaced and foam plastic was placed over the line bonds as needed.

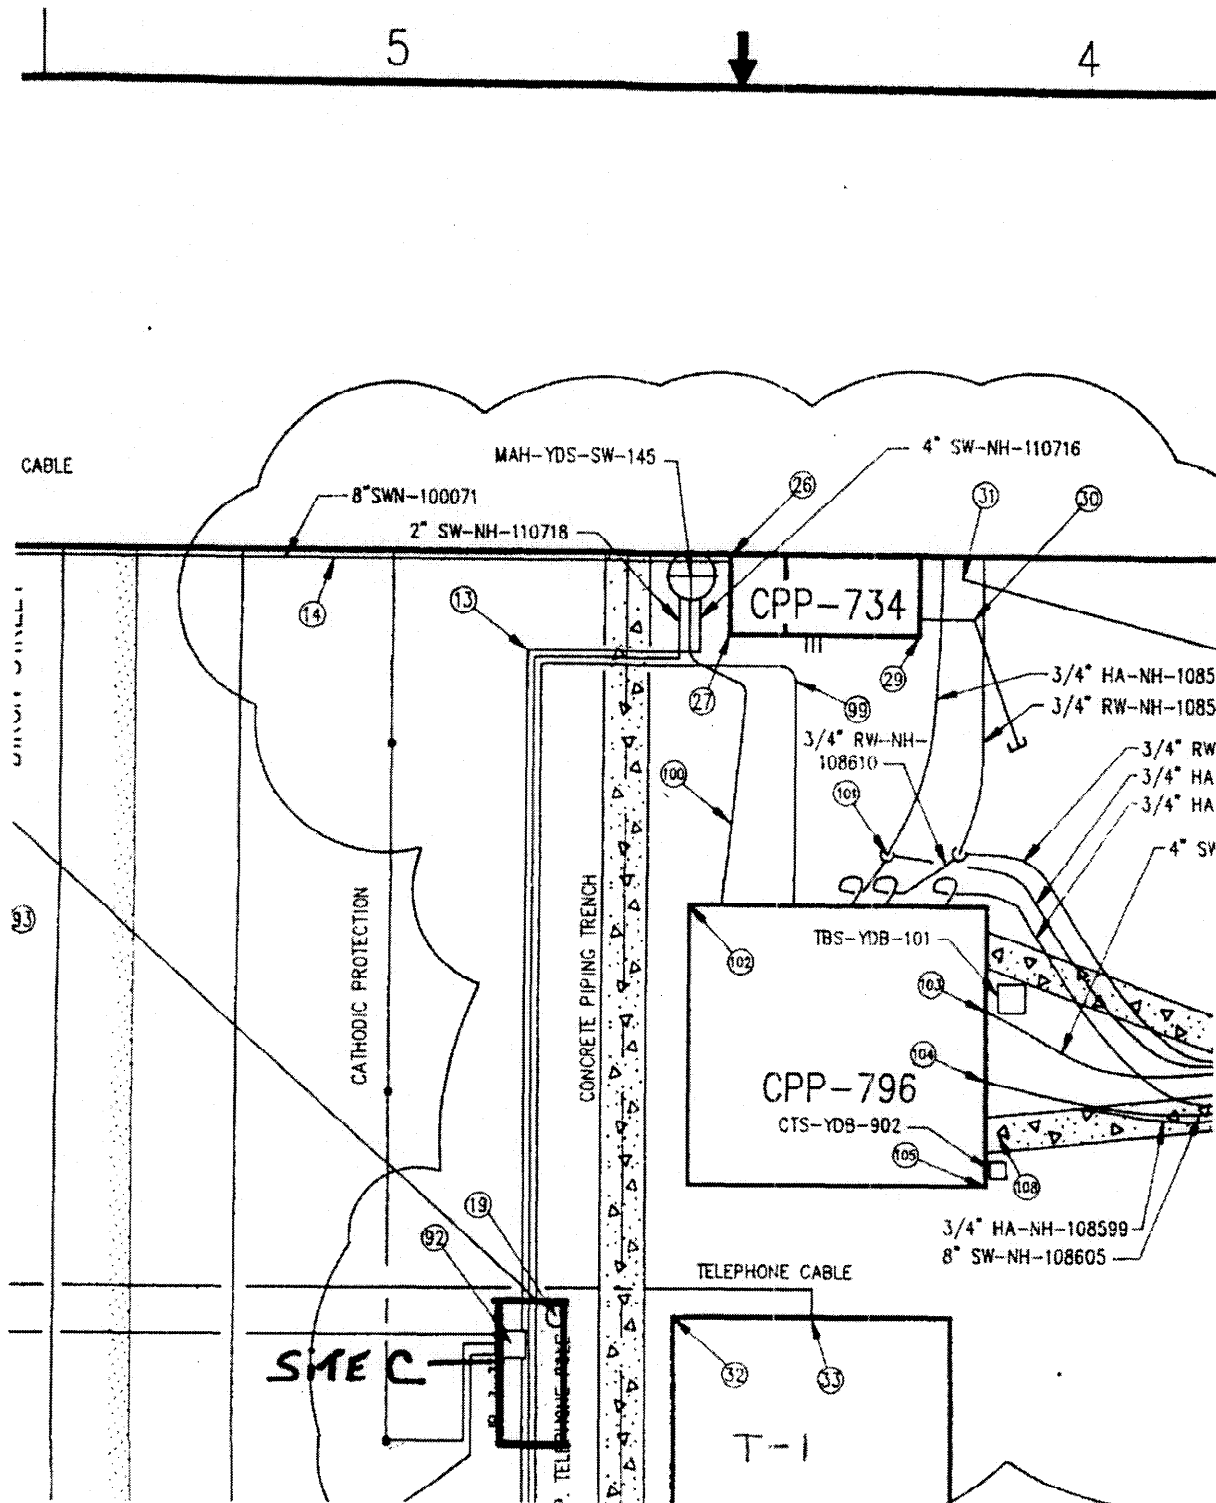
Figure 4-5. Schematic from WINCO (1992b) showing Location (Site) C.

The incident at Location C (Figures 4-2 and 4-5) is associated with a spill of nonradioactive, nonhazardous waste water; this spill occurred during the repair activities associated with Location A. Location C is located approximately 10 ft west of the northwest corner of CPP-T1 and runs parallel to three plastic underground service waste lines: SW-NH-110716 (4-in. line), SW-NH-110717 (6-in. line), and SW-NH-110718 (2-in. line). On September 2, 1987, a backhoe struck and ruptured lines SW-NH-110717 and SW-NH-110718. At the time of the incident, only line SW-NH-110717 was in use.

The line, the 6-in. SW-NH-110717, was one of the main service waste pumpout routes from CPP-734 (after monitoring) to the percolation ponds, serving the west side of the service waste collection system. Waste in this line had received all the monitoring and sampling that it would ever get upstream of the rupture. The line was in service at the time of the break, accounting for the large volume of discharge (approximately 500 gal) (Reference 6, WINCO [1992b]). Although the flow was curtailed as much as possible, the SW-NH-110717 line discharged into the excavation hole due to backflow from CPP-709 pumps (east side of service waste system) until temporary repairs were made. During repairs, the liquid waste was monitored and sampled; it was found to be nonradioactive and pumped to the Idaho Chemical Processing Plant (ICPP) Drainage Ditch System (see following paragraph). (Note: ICPP is now the Idaho Nuclear Technology and Engineering Center [INTEC]) Permanent repairs were made at a later date (Critique Report No. 87130, Reference 2, WINCO [1992b]). The composite sample for the month

preceding the rupture (August 1987) showed that RCRA hazardous metals were all <0.5% of their respective toxicity levels (Reference 8, WINCO [1992b]). This gives good reason to believe that no hazardous materials were released. Any potential contaminants would be below the limits requiring a risk assessment (see Contaminant Worksheet for Location C, WINCO [1992b]).

The line, the 2-in. SW-NH-110718, which runs from the reverse osmosis system in CPP-603 to CPP-734 for monitoring, was not in service at the time it was damaged, so no immediate release to the environment from this line occurred. In addition, it was initially believed that the line was not ruptured, so it was returned to service. It then leaked into the excavation, but a much smaller amount than released from line SW-NH-110717 (possibly 10-20 gal). The reverse osmosis unit was used to prepare makeup water for addition to the CPP-603 basins. The liquid in the line was the reject stream that contains the minerals from the groundwater, in somewhat more concentrated form. There is no reason to suspect hazardous materials were transferred in this line. The minerals are those normally found in water (Reference 5, WINCO [1992b]).
